# ROCHESTER CASTLE

## CONSERVATION PLAN

### UNDERSTANDING AND SIGNIFICANCE

*The Paul Drury Partnership*

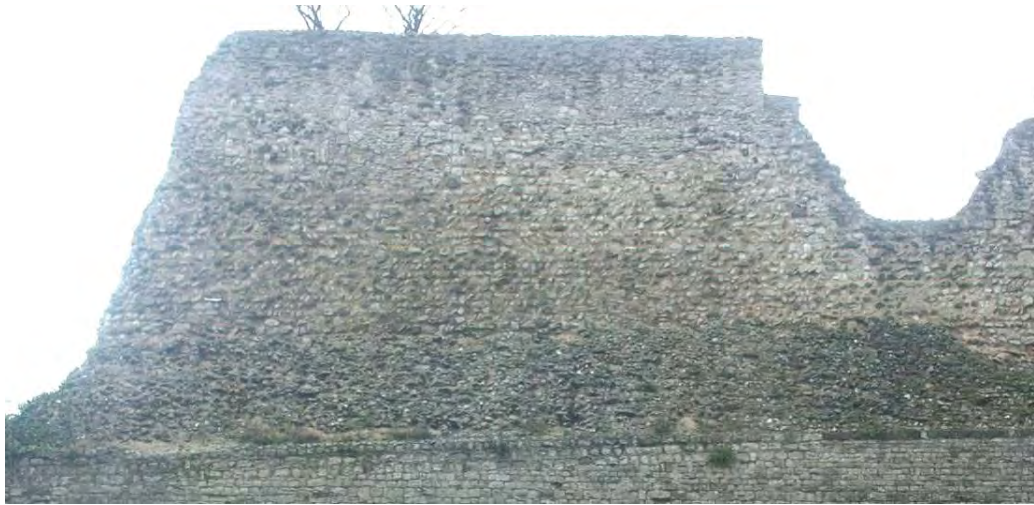
*West curtain wall: Norman walling above Roman foundations and 20<sup>th</sup> century retaining wall with inserted 13<sup>th</sup> century windows*

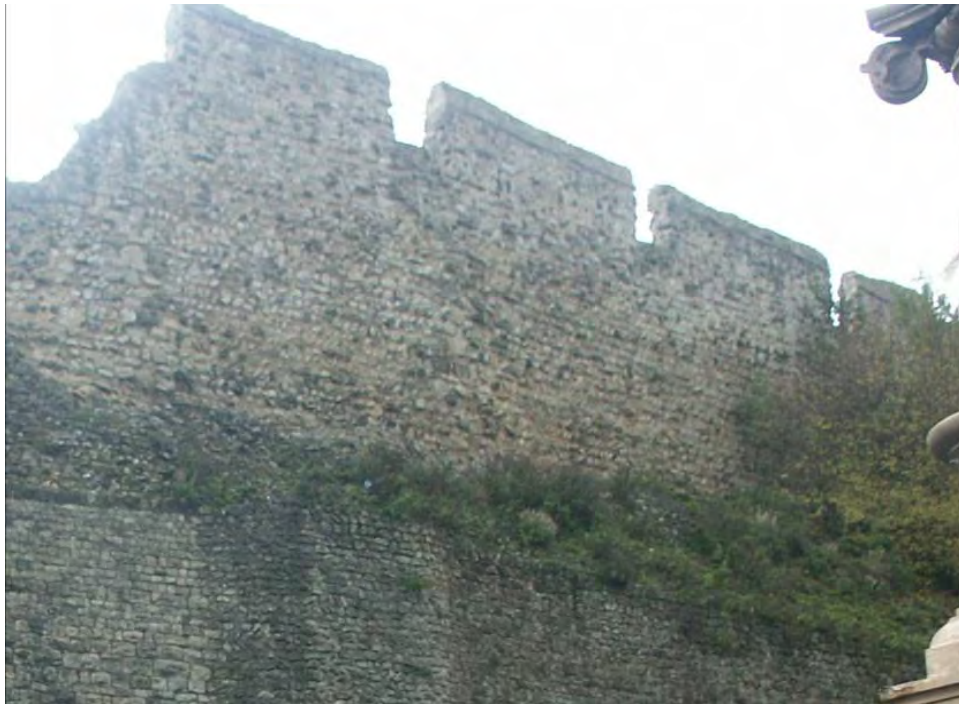
*West curtain wall: Norman walling above Roman foundations and 20<sup>th</sup> century retaining walls with 18<sup>th</sup> century crenelations<sup>11</sup>*

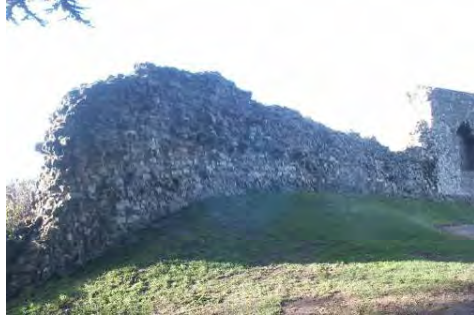
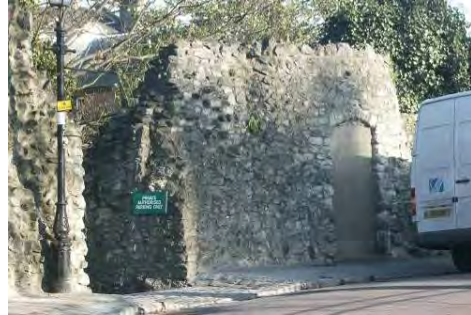
- 4.3 Two other sections of wall have generally been attributed to Gundulf (e.g. Flight and Harrison 1978). The first is in the south-west corner and the second is to the north-east, and has been incorporated in the rear garden walls of properties on the High Street. They only survive as much rebuilt rubble cores, but both are much more substantial than the west curtain wall, and the

south-west section at least must be later, being of one build with the pointed relieving arch incorporated in the 13<sup>th</sup> century rebuilding of the curtain at this point to accommodate a building.

*Walling attributed to Gundulf in south-west and north-east corners of curtain wall*

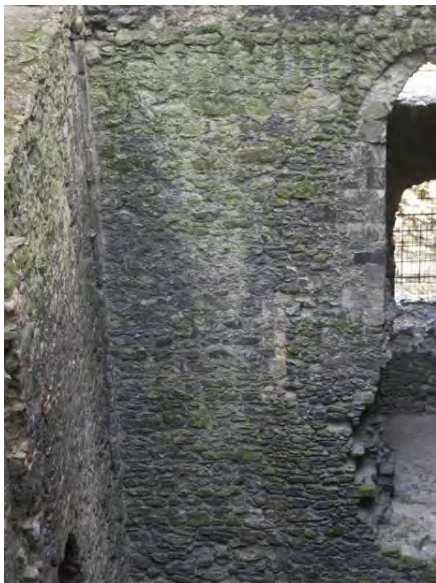
5.1.4 The main entrance was at first floor level, where a portcullis<sup>14</sup> guarded the door from the forebuilding. A postern<sup>15</sup> on the east side, near the north-east stair, appears primary, and probably opened onto a timber bridge connected to the wall walk of the curtain in a similar fashion to the keep posterns at Colchester and Norwich. A second postern in the forebuilding is therefore probably secondary, as it is unlikely that two doorways would be needed in this area. It also appears that there was a large arched opening, in the inner face of the east elevation of the southern room, possibly framing a window. Traces of the quoining<sup>16</sup> for this survive embedded in later (13<sup>th</sup> century) rebuilding work.

*First floor, east side: quoining of blocked archway*

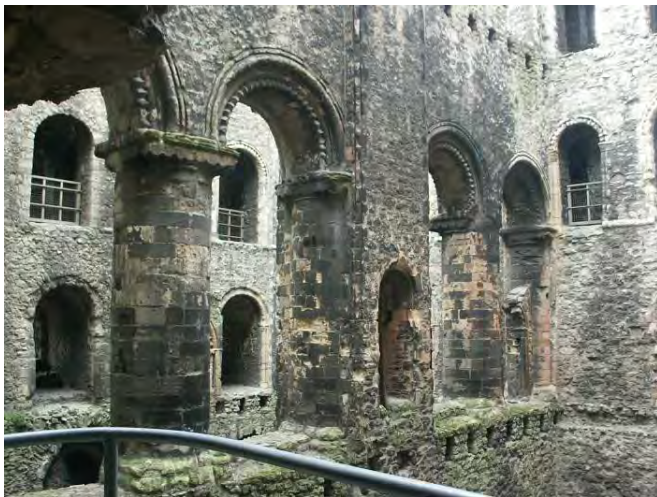
5.1.5 The principal reception area is likely to have been on the second floor. This is a double height space covering the entire storey, with a Romanesque<sup>17</sup> arcade (of uneven arch sizes, the easternmost arch being significantly larger than the rest) carrying the cross wall. A continuous high level mural<sup>18</sup> gallery is contained in the thickness of the walls. As built, this space appears to have been conceived to be used flexibly, with timber screens, the sockets for which are still visible, infilling the arches of the arcade. It is probable that these were replaced by a stone screen very soon after the keep was finished. Numerous early views of the interior of the keep (Medway Archives DE402/7/53) show a solid stone screen, the foundations of which are still visible in a reconstructed form. This cannot be primary, as there is a straight joint between this work and the columns behind. However, the arched head of the doorway in the western bay is of an identical style to the main arch, suggesting that it was inserted very soon after the initial construction of the building or even a result of a change in the design during the construction. Other large keeps, such as Colchester and Norwich, underwent a complex evolution during the building process, and it is likely a similar process occurred at Rochester. It is of course possible that the stone screen was inserted after the doorway to the north, but it is difficult to see what purpose this doorway would have on its own. The screen was certainly in place before the fire that gutted the keep, as scorch marks stop abruptly at the line of the screen (Goodall 2006:285).

*Second floor: arcade*

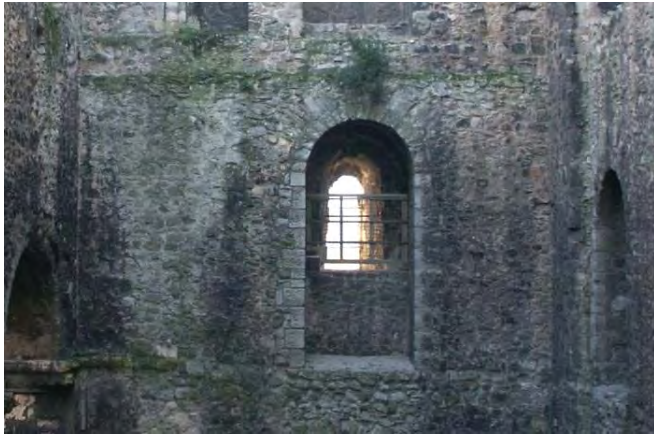
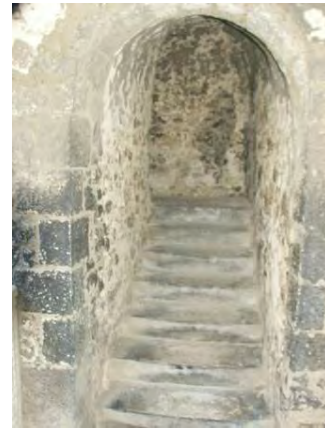
5.1.6 The southern part of the eastern mural passage rises by six steps at the cross wall before falling three steps. The rise is clearly primary, while the fall of three steps is associated with the 13<sup>th</sup> century rebuilding of the south-east corner of the keep. Previous interpretation was that it was to strengthen the wall around the arcade and accommodate the latrine vault below (Clark 1884:414, followed by Payne 1905:180). However, this is unsatisfactory, as no such strengthening was necessary on the west side. Goodall has suggested that as built the gallery rose up six steps and remained level in order to clear an arch below. He tentatively identifies a block of Caen stone in the wall as a surviving fragment of this feature (Goodall 2006:282). This appears a satisfactory solution to this anomaly, the rise in the gallery being just high enough to accommodate an arch of the same dimensions as partially survives on the floor above. This arch may have framed a blind recess or a tall window. The remains of a series of doors are visible at gallery level. These would have enabled the north side of the gallery to be separated from the south side and the stair towers to be sealed off.

*South-east corner of the keep, raised gallery*

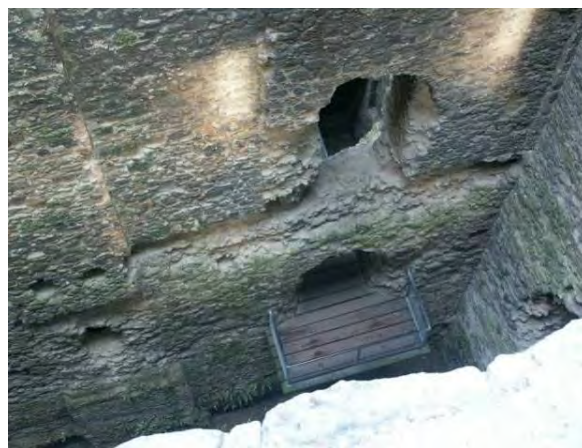
5.1.7 It is also likely that there was some sort of division running across the southern portion of the first and second floors. A pilaster<sup>19</sup> supporting this division can be seen running the entire height of the first floor. At second floor level there is a scar in the south side of the eastern column of the arcade, which rises to capital level. Unlike the arcade screen this feature was clearly primary, as it has been coursed into the arcade. The height and form of this division is difficult to assess, as the north face of this wall appears to have been rebuilt post 1215, a possible solution is a single arch spanning the southern half of the building, as this would frame views of the large arch in the east wall (Fig. 11). It is possible that the floor consisted of stone flags supported by timber beams. While unknown in later English contexts similar floors, consisting of boarding covered by an earth loam that forms a bed for tiles are common in medieval and later French buildings. An earlier version of the technique, using stone flags, is possible here and would account for the relatively wide space between the top of the joist slots and the base of the second floor window and door openings.

*First floor, southern section, pilaster*

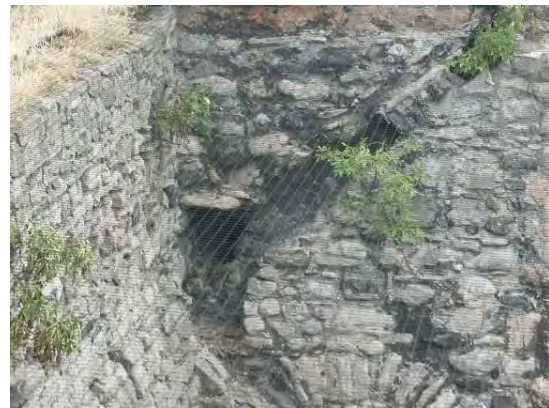
*Northern compartment, east wall, roof scar*

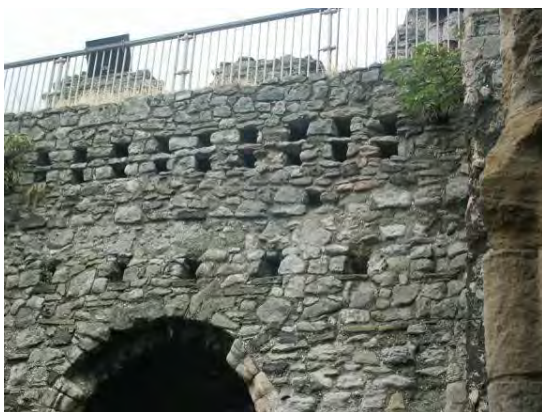
strengthened with either collars or scissor braces<sup>20</sup>. Lead would have been the most likely original roof covering; the roofs were certainly leaded later (p50). Gutters would have been lead lined (the scar for this gutter, with original lead built into the wall) is still extant on the northern internal elevation). These would have discharged via drains through the east and west walls, which survive complete for the northern roof but have been largely blocked for the southern roof, only surviving externally on the northern side of the west elevation. Two tiers of nesting boxes for pigeons are extant in the north wall. These were extensively rebuilt during the 19<sup>th</sup> century Payne (1905:178) but a reference in Clark confirms that they are an original feature (Clark 1884:417). Goodall has convincingly argued that the wall walk was conceived as having brattices (oversailing timber hoardings) from the start, as the surviving slots for projecting timbers are significantly larger than those of the 13<sup>th</sup> century rebuilding works (2006:272). Payne identified blocked openings in the centre of the wall walks on all sides bar the south, via which the brattices were reached (Payne 1905:180). These are still visible externally.

*North elevation, detail of rafter sockets and pigeon holes*

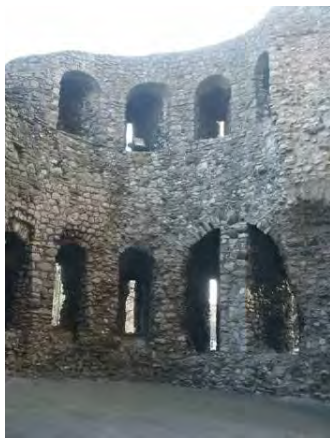
6.2.1 In 1223 a Royal writ ordered the Sheriff of Kent to make good 'the breaches of the wall of our Castle which formerly fell'. As a separate order is given to repair the keep in 1226 this presumably refers to the curtain wall (Allen Brown 1986:13). This must have included the building of the drum tower (tower one) at the south east corner of the curtain wall, as the curtain wall in this area would have been destroyed by the mining of the keep. As built, this tower appears to have been a two-storey structure with a timber floor. The position of the arrow slits on the upper floor suggests that only half the tower was floored, and that it was open to the gorge. There is a clear break between the ground and first floors of the tower, and a marked difference between the dressed stone arrow loops of the ground floor and the rubble finish of the first floor loops. However, the similarity of the first floor to other fabric dated to the 13<sup>th</sup> century, particularly the southern wall (discussed below) and the section of walling encapsulated in the west wall of tower two, suggests that this is the result of a construction break rather than an entirely separate phase. The suggestion that this tower was rebuilt and heightened in the 14<sup>th</sup> century (Gifford 1997:18) is thus erroneous. The insertion of a pillar into what appears to have originally been a large arch at ground floor level is likely to have been contemporary with the construction of the first floor. The west face of the tower would have originally contained an arrow loop on each floor which would have covered the face of the southern curtain wall; the springing for the rere-arch of the ground floor loop still survives.

*Drum Tower (Tower One), interior*

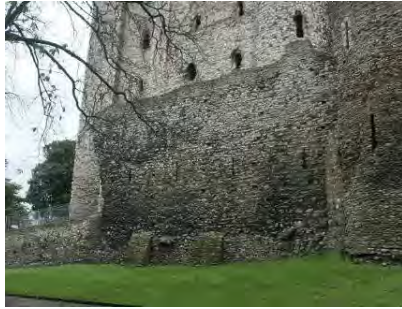
- 6.2.2 The adjoining stretches of the south and east curtain walls must also have been replaced at this time, as they too would have been destroyed by the fall of the keep. As discussed above, this is clearly of a different built to the ground floor of the drum tower, as the way in which the two structures have parted company suggests that they were never coursed in together. However, similarities in the stonework suggest that the first floor and curtain are part of the same campaign.

*South curtain wall, exterior*

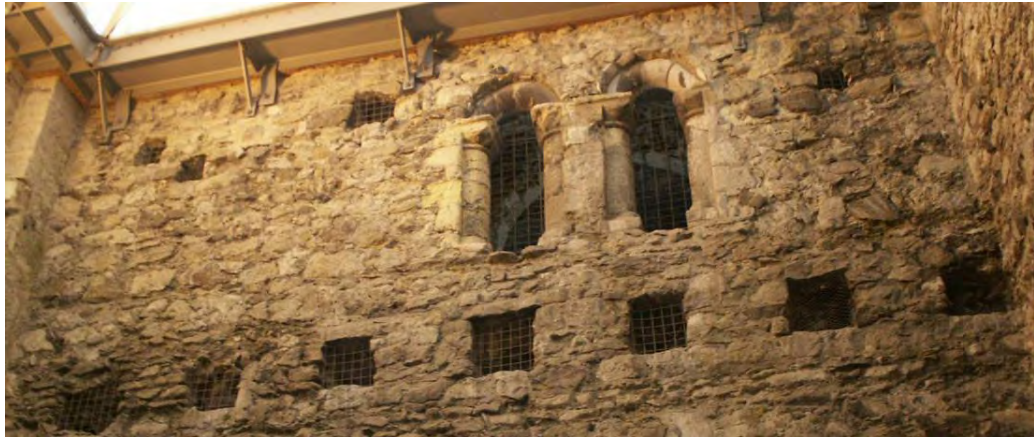
- 6.4.5 It is possible that the gallery window in the north elevation, which opened out onto the forebuilding roof, was blocked during this phase. The most likely cause for this would have been the conversion of this roof into a cistern. There are traces of internal drains under the roof level which may be

*Forebuilding, window blocked during medieval period*
